**RECONNAISSANCE GEOLOGICAL REPORT OF PROPOSED SITE OF SHRI JAICHAND S/O SHRI VIDYADATT FOR THE CONSTRUCTION OF OWNER DRIVEN CONSTRUCTION FOR HOUSING (ODCH) VILLAGE-KOTGAWAN, TEHSIL- MORI, DISTRICT- UTTARKASHI KHASARA NO-1772 & AREA-0.020 ha**

**Date of Inspection: 18/01/2014**

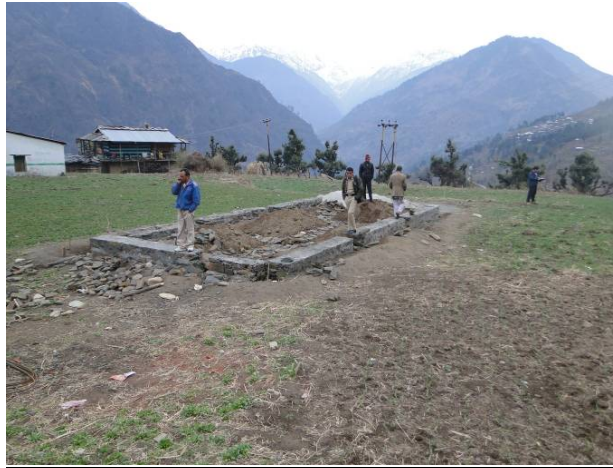
**Close view of the proposed site**

At the proposed site, thick and consolidated soil cover which surrounded by and present on with rock fragments of gneiss varying in size from 2-5cm, with fined grained blackish- brown clay soil matrix are found. The trees near the proposed site are standing straight which shows there is no active movement in the area.

1. Inclined retaining wall at the uphill in W direction and downhill in E direction foot way side with depth of foundation more than the foundation depth of the house with provisions of weep holes and sufficient gap of about 0.5-1.0m in between the backside retaining wall and the proposed construction should be constructed. And also, proper drainage system between the retaining wall and the wall of house should be developed.

2. The surface drainage should be properly planned through lined drain/pipe, so both, rainwater from uphill side as well as waste water from the existing houses to be release safe place at down-hill along a channel with more dimensions than that of maximum possible volume of water.

3. The foundation depth of the houses must be as per the compactness of the overburden material in the proposed site.
4. Inclined retaining wall at the toe of the proposed site with provision of weep holes at specific distance should be constructed
