**RECONNAISSANCE GEOLOGICAL REPORT OF PROPOSED SITE OF SHRI BACHAN LAL S/O SHRI SUMAN LAL FOR THE CONSTRUCTION OF OWNER DRIVEN CONSTRUCTION FOR HOUSING (ODCH) VILLAGE-KURDA, TEHSIL- PUROLA DISTRICT- UTTARKASHI KHASARA NO –4316 & AREA –0.014 ha**

**Date of Inspection: 30/12/13**

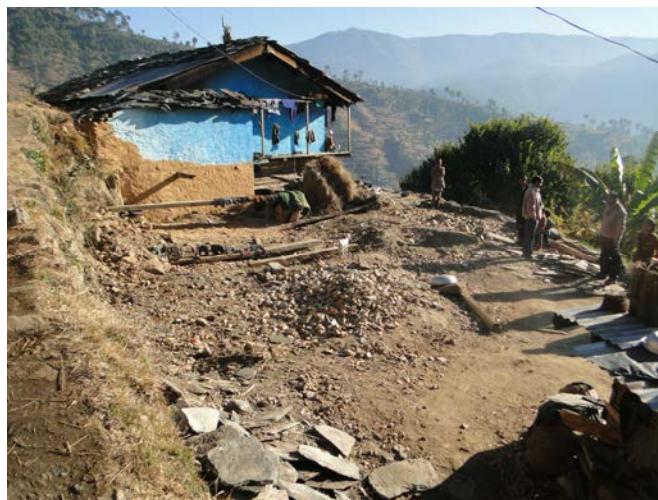
**Close view of the proposed site**

At the proposed site, thin and consolidated soil cover with rock fragments of phyllite varying in size from 5-10cm, with fined grained light brownish silty soil matrix are found. Boulders were embedded in the soil of varying size from 60cm to 80cm approx at and around the proposed site. The soil water saturation is moderate to high in the western side of the proposed site due to Khala-Nala, there is no active movement in the area. Some construction work is already under progress at the proposed site.

1. Inclined retaining wall at the uphill and downhill side with depth of foundation more than the foundation depth of the house, with provisions of weep holes and sufficient gap of about 2-3feet in between the backside retaining wall and the proposed construction should be constructed. And also, proper drainage system between the retaining wall and the wall of house should be developed.

2. The surface drainage should be properly planned through lined drain/pipe, so both, rainwater from uphill side as well as waste water from the existing houses to be release safe place at down-hill along a channel with more dimensions than that of maximum possible volume of water.

3. The foundation of the houses must be kept on in-situ rock, if found at accessible depth.
4. Massive plantation of trees, bushes and grasses which can hold the soil mass and retained the debris with dense and long rooted, wide/broad leafed flora at the uphill side and in southern side must be done to protect the soil erosion and minimize the surface erosion of the subsurface rocks.
