**RECONNAISSANCE GEOLOGICAL REPORT OF PROPOSED SITE OF SHRI  
RAJKUMAR S/o SHRI VIKRAM SINGH FOR THE CONSTRUCTION OF OWNER  
DRIVEN CONSTRUCTION FOR HOUSING (ODCH)  
TOK JAKHURI, VILLAGE GHAINCHUWAN, TEHSIL- MORI- DISTRICT  
UTTARKASHI, UTTARAKHAND  
KHASARA No. – 3198(d) & AREA – 0.020 ha.**

**Date of Inspection: 04/02/14**

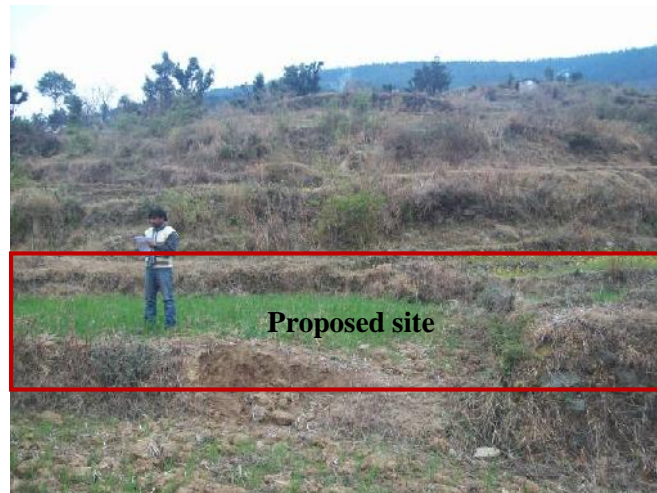
**Close view of the proposed site**

The proposed site is on colluvial overburden material thus no insitu rock is found but a few boulders varying in size range from 0.5m to 2m approx are found embedded in the

brownish soil with fragments of quartz and gneiss of 2cm-7cm approx size. The soil is consolidated; the rate of infiltration is low making the soil water saturation low. At the proposed site location the water seepage is low. The trees at the uphill slopes are standing straight.

1. Inclined retaining wall of 2m approx height and 3m approx length at the SE backside boundary and also in the NW toe boundary of the site of 3m approx length with depth of foundation of the backside retaining more than that of the foundation depth of the house, with provisions of weep holes and sufficient gap of about 2-3feet in between the backside retaining wall and the proposed construction should be constructed. And also, proper drainage system between the retaining wall and the wall of house should be developed.

2. The surface drainage should be properly planned through lined drain/pipe, so both rain water as well as waste water from the existing houses to be release safe place in NE direction along a channel.

3. The foundation depth of the houses must be as per the compactness of the overburden material at the proposed site.
4. Framed structure with deep column and light roof must be constructed as the area falls in the earthquake zone IV, so it is essential that the house must be constructed with latest earthquake resistive techniques.

5. Massive plantation of trees, bushes and grasses which can hold the soil mass and retain the debris with dense and long rooted, wide leafed flora must be done in the SE uphill side to protect the soil erosion and minimize the surface erosion of sub-surface rock.

6. The soak pits and toilet foundations must be quiet away in NE side from the house so that the foundations are not directly affected from subsidence due to excessive seepage.

7. The premises of house must be made 'pukka' in order to avoid excessive seepage of the surface water.
