**RECONNAISSANCE GEOLOGICAL REPORT OF PROPOSED SITE OF
VILLAGE-KANSI, TOK- SARI, TEHSIL- CHINYALISAUR, DIST.UTTARKASHI
PVT. LAND AREA: 1.795ha AND REVENUE LAND AREA: 0.101ha**

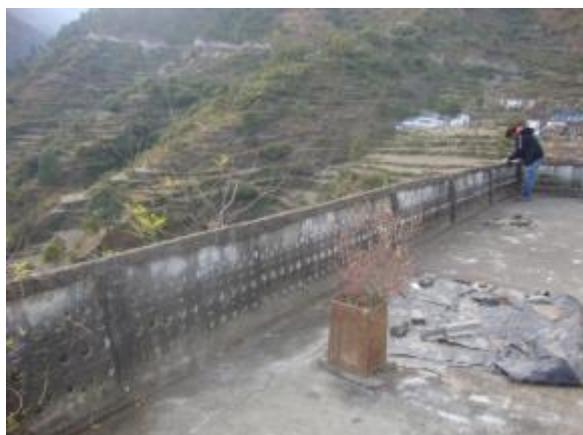
Some cracks are found in the affected houses of varying length from 3-3.5m and 0.5m wide. The damaged houses are tilted approximately 7°-8° in South direction towards Panihar Nala.

Tilted roof of an affected house.

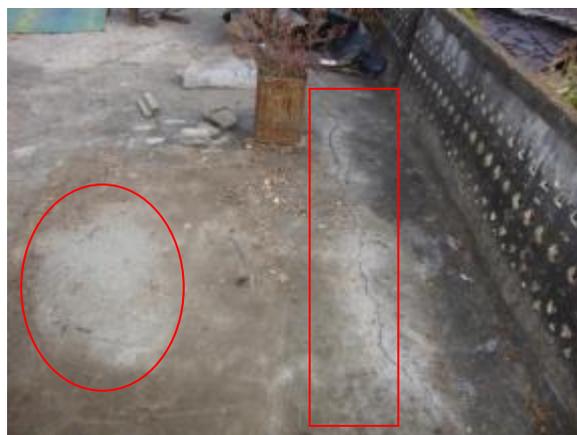
Cracks observed on roof of the house.

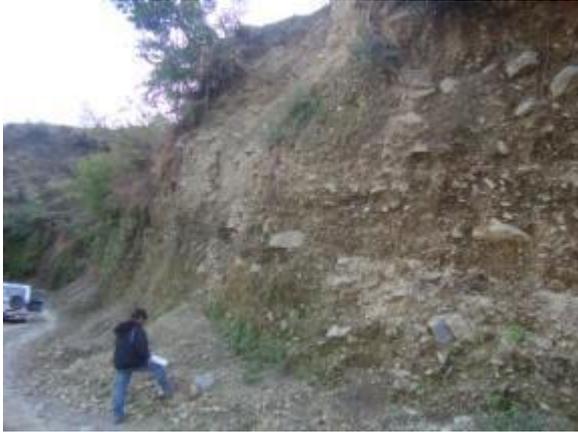
Along the Kanshi-Manjket road, many small active landslides are seen. Also, at the toe of the Kanshi Village, all along the road, the overburden material of 15-18m vertical and 200-250m horizontal span is present which is sliding towards NE direction. Here the overburden is composed of angular to sub-angular fragments of phyllite and quartzite with quartz veins and some boulders of about 15-25cm size of phyllite and quartzite. The phyllite fragments are highly damaged due to water saturation. The road cutting is also affecting the entire area

Overburden sliding towards NE direction.

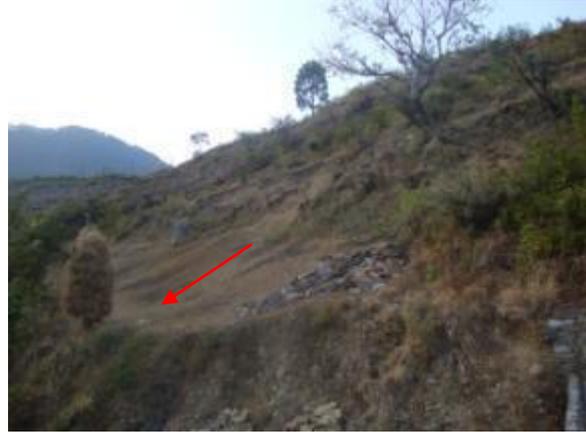
Tilted terraces showing creeping.

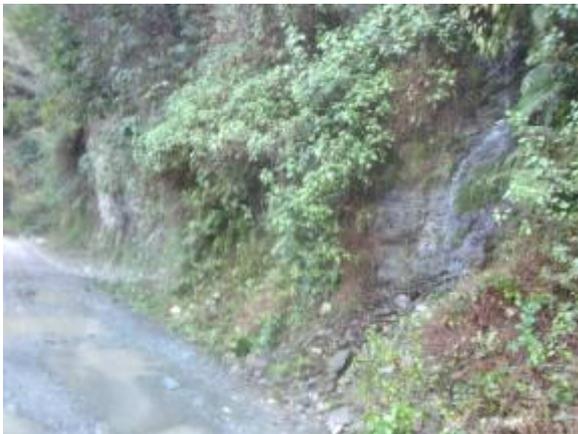
The perennial Ghattukhal Nala is flowing from SW to NE direction and falls on coordinate- N 30°33'16.4" E 78°17'32.0" and elevation 1150m. The Nala becomes very active during the monsoon as per the villagers and is adding to the water saturation in the area. There are 2-3 natural springs in the area and water seepage is very high.

Natural spring showing high seepage.

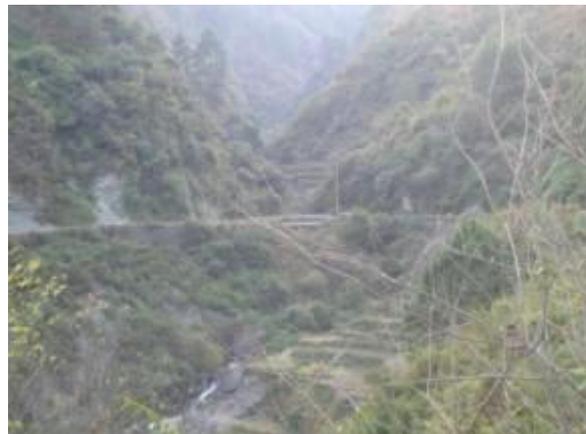
A far view of Ghattukhal Nala.

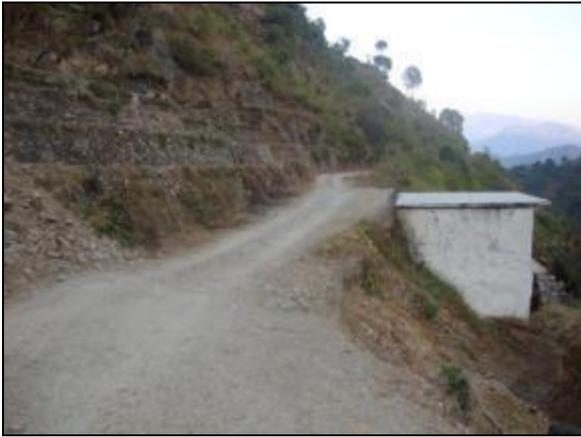
An extent of 10-15m the road is subsided lightly approximately 7-8cm with the downhill slope of the area, which is about 32°-34° towards East direction. In the nearby area almost 250-300m from Ghattukhal Nala, an old landslide is observed in which large boulders 20cm-1.5m size along with phyllite and quartzite fragments are present with the soil matrix.

Subsided part of the road near Ghattukhal Nala. Old landslide zone near Ghattukhal Nala.

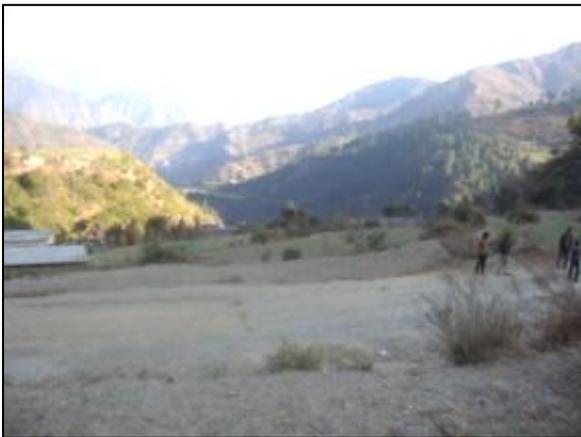
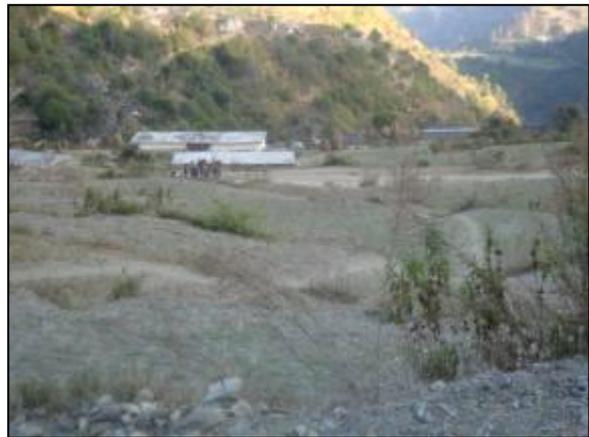
The proposed area is situated on hill slope in Sari Tok, village Kansi and falls on co-ordinates- N 30°33'32.0" E 78°17'18.9" and elevation 1351m. The overburden thickness in the proposed area is 2-3m approximately. The overburden material includes grayish brown color soil with angular fragments of slate and phyllite approximately 1-7cm in size and is moderately compact without saturation. The downhill slope of the area is 10°-12° towards East direction and uphill slope about 48°-50° towards East direction. There is Paniharkhal Nala 70-80m approximately in Northern side of the proposed land area and is flowing towards NE direction.

Different views of the proposed Sari name Tok.

1. The new houses must be constructed keeping a 50-55m distance from the Paniharkhal Nala and there must be appropriate distance between the newly constructed houses.

2. Westward inclined retaining wall of approximately 2.0-2.5m must be constructed on the Eastern boundaries of the terrace like plots with proper weep holes at a minimum 0.5m distance apart.

6. Proper channelized linear cemented drainage for natural water disposal with capacity of optimum volume of water should be constructed towards North direction for safety of houses from unwanted surface and subsurface water that may enhance vulnerability.
