**RECONNAISSANCE GEOLOGICAL REPORT ON LANDSLIDE AFFECTED
VILLAGE-NERI, PATTI-GAMRI, TOK- DIKHOLI, TEHSIL- CHINYALISUR,
DISTRICT UTTARKASHI**

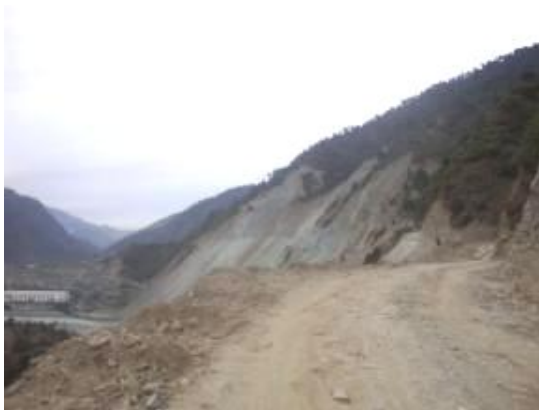
The area is affected by a huge landslide for approximately 1.2km length along the Jogat Motor road at the toe of the Village Neri. The slope of overburden at the toe near the road is 36° towards NE direction which increases in the upper part of the landslide to 72° towards NE direction.

A view of the active landslide in the area.

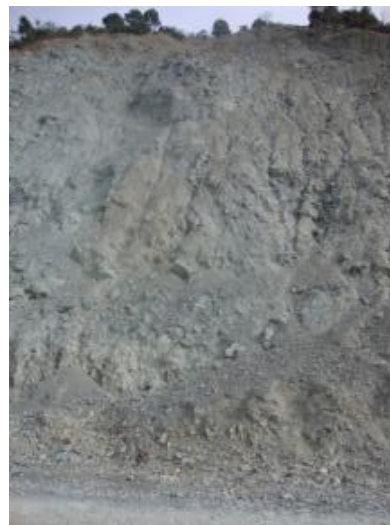
Landslide debris material.

The landslide debris is colluvial and includes angular to sub-angular fragments of phyllite, mixed quartzite with quartz veins and fine matrix. The phyllite fragments are approximately 60% while quartzite fragments are 20% and rest is fine soil matrix. The material is sliding and coming out towards the slope direction. There is two type of slide movements active in this slide. One movement is towards the hill side which is highly active in nature and other is slow movement towards the downslope. At many places there is moderate to high water saturation in the loose sediments of the slide which is further making it unstable.

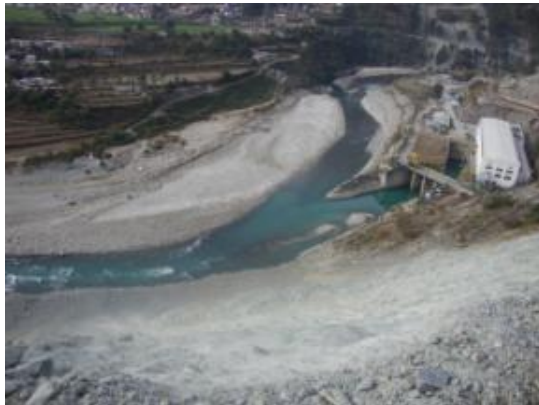
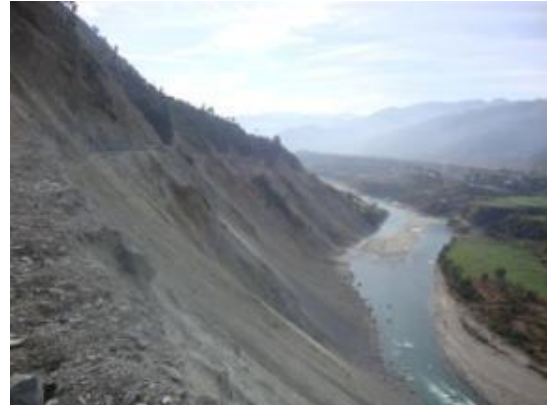
Toe cutting by Bhagirathi River below the village lead to this huge landslide in colluvials.

The road cutting for Jogat Motor marg is making the slope unstable for the village portion. The Bhagirathi River is continuously cutting the toe of the village and the meandering of the river and the road cutting are collectively affecting the entire area. The toe cutting by the river is the main cause for this huge landslide in the area which is highly active.

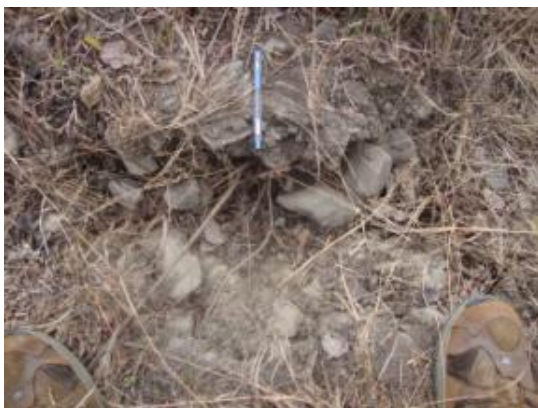
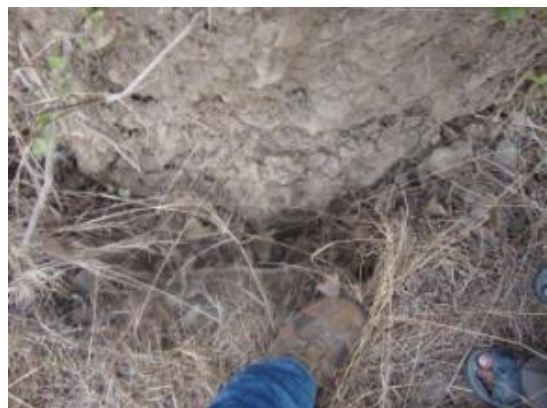
Developed cracks in the village Neri.

In the village, above the road some cracks have developed and a vertical detachment of 0.3-0.6m in the overburden is observed. This detachment extends horizontally for more than 45m approximately. Some boulders of 1.2-1.5m are also seen which are providing some stability but due to the cracks they are also moving towards the slope. In the village tilted electric poles are seen showing active creeping taking place towards the westward slope.

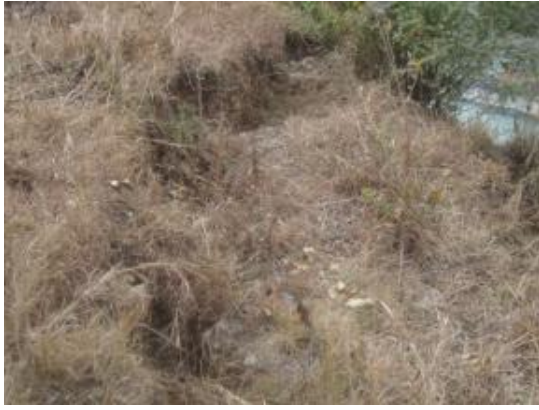
Detached portion of the terrace.

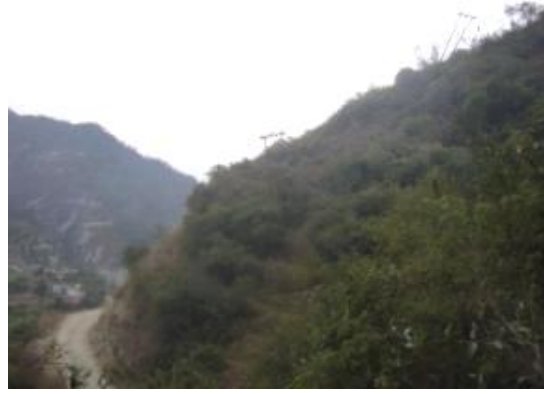
Both fast and slow creeping are active.
