**RECONNAISSANCE GEOLOGICAL REPORT OF SHRI TRREPAN SIGH S/o SHRI
GANGA DATT FOR THE PROPOSED CONSTRUCTION OF OWNER DRIVEN
CONSTRUCTION HOUSING (ODCH)
VILLAGE-BARSHU, TEHSIL- BHATWARI, DIST.- UTTARKASHI
KHASRA No.-893, 894 & AREA-0.026 ha.**

Date of Inspection: 22-12-2013

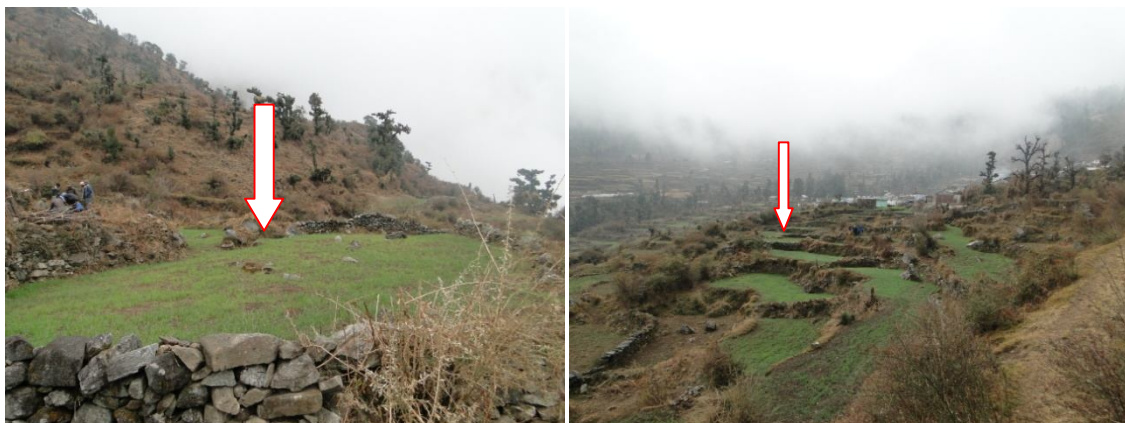
The proposed site situated on coluvial terrace and manmade flat cultivated land. At 500m horizontal distance in the south-east direction on the right bank of Swari Gad. In coluvial terrace about 1.5-2m thickness of overburden, in overburden Gneiss and quartzite fragments varying size from 1-5cm with fine grain brownish soil matrix. The proposed site is cultivated and low vegetated. General slope of the proposed site is 20°-25°, uphill slope from proposed site is trending 30°-35° and downhill slope is trending 25°-30° to wardseast direction.

The close view of the proposed site

In toe of the Barshu village towards Swari gad side is continue erosion on rainy session that is landslide formed in the right bank of the river. Due to landslide in river bank that cause is subsidence seen around proposed site. But the proposed site is 100-150m distance from subsidence zone and toe of the hill. About 30-40m hillside from proposed site slightly weathered and moderately jointed gneiss with alternate bands of quartzite is present. The rock is dipping 20° towards N 10° E direction, joints J1 dipping 70° towards S 50° E and dipping 55° towards S 70° W. Presently the site is suitable for house construction.

Based on above surface geological observations of the proposed area, geologically suitable for building construction and the following remedial measures are recommended:

1. The surface drainage should be properly planned through lined drain/pipe, so both, rain water from uphill side as well as waste water from the existing houses to be release safe place at down-hill along a channel with more dimensions than that of maximum possible volume of water.

2. The foundation depth of the houses must be as per the compactness of the overburden material in the proposed site.
3. Massive plantation of trees, bushes and grasses which can hold the soil mass and retain the debris with dense and long rooted, wide leafed flora must be done to protect the soil erosion and minimize the surface erosion of sub-surface rock.

4. Framed structure with light roof must be constructed as the area falls in the earthquake zone IV, so it is essential that the house must be constructed with latest earthquake resistive techniques.

5. A inclined retaining wall at backside; with provisions of weep holes and sufficient gap of about 0.5-1.0m in between the backside retaining wall and the proposed construction should be constructed. And also, proper drainage system between the retaining wall and the wall of house should be developed.
