**RECONNAISSANCE GEOLOGICAL REPORT OF PROPOSED SITE OF SHRI NARENDER SINGH S/O SHRI KALAM SINGH FOR THE CONSTRUCTION OF OWNER DRIVEN CONSTRUCTION HOUSING (ODCH) TOK BAL KHELA, VILLAGE DIDSAARI, TEHSIL- BHATWARI- DISTRICT UTTARKASHI, UTTARAKHAND KHASARA NO – 2116a & AREA – 0.020 ha.**

**Date of Inspection: 11/12/13**

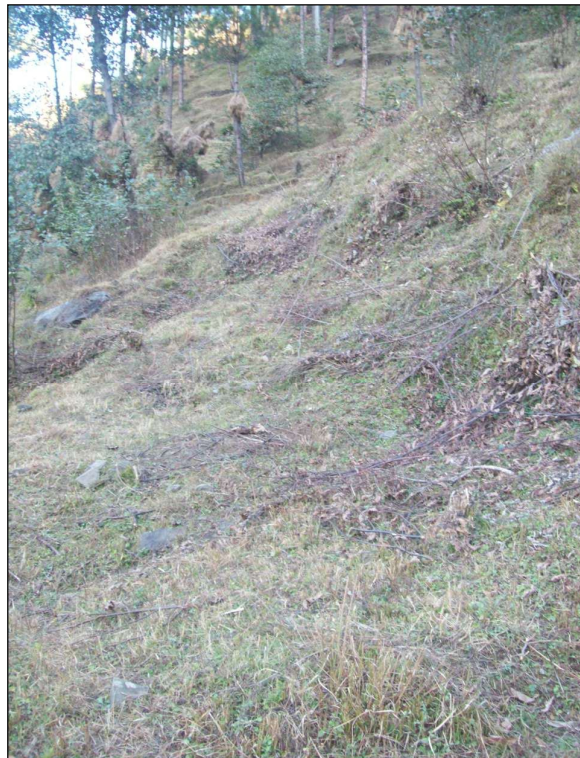
At the site thick alluvial soil cover and quartzite rock fragments of size 3-4cm in the soil matrix are found. At the proposed site the soil is consolidated, the rate of infiltration is high making the soil water saturation high as the area receive high rainfall.

**Side view of the proposed site for construction**

1. At proposed site, the slope & the landmass is consolidated but due to high rate of water infiltration the proposed site is not much stable thus, proper foundation with a with a fine depth as per compactness and porosity at the site is recommended to stabilize the site.
2. Inclined retaining wall at the backside of the site with a gap of minimum 2-3feet is recommended with a proper drainage system between the retaining wall and the wall of house.
3. Proper drainage for rainwater and sewage discharge is strongly recommended.
4. Framed structure must be used as the area falls in the earthquake zone IV, so it is essential that the house must be constructed with latest earthquake resistive techniques.
